Las Vegas ReVISION House™

Introduction

Existing Home Energy Analysis

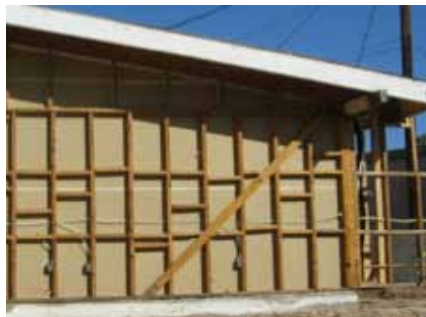
Fig. 10: Open-cell foam insulation

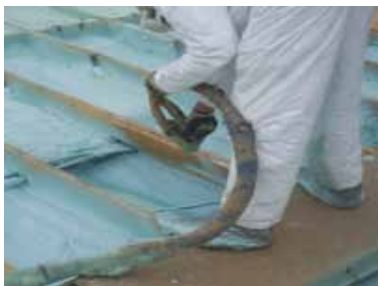
Work on the roof proceeded using a similar strategy, with all roof covering and the roof decking removed leaving the rafter framing and the ceiling gypsum board attached to the bottom of the sloped rafters. Where a sloped ceiling did not exist (but a small attic space did) ledgers were attached along the bottom edge of the rafters and gypsum board was laid onto the ledgers. All 2 x 10 rafter spaces were then filled with 8.5” of closed-cell foam leaving a small 1” void at the top. The result is an R-55.25 assembly with outstanding air-sealing.

Fig. 12: Applying Closed-cell foam at rafters Fig. 13: 8.5” of foam in 2 x 10 rafters

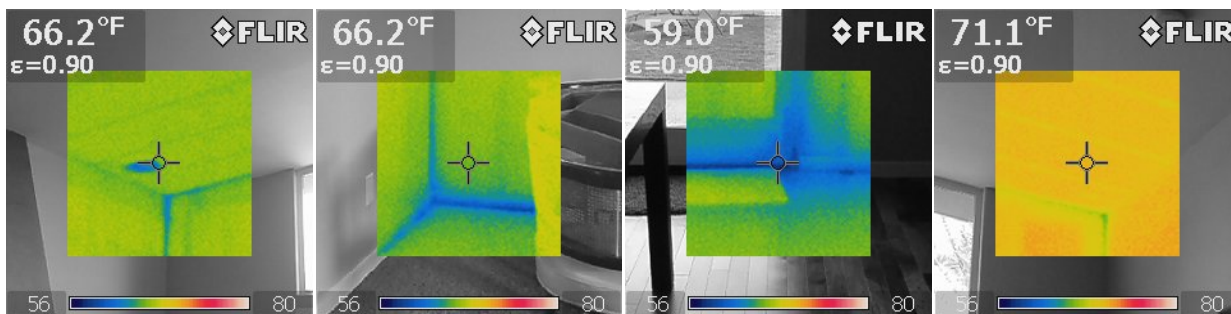
In addition to finding air leaks, the IR camera was used to detect thermal bypasses in the building shell. As noted above, the largest thermal bypass in this home was located along the edge where the wall meets the slab. Most other bypasses detected in the pre-retrofit audit were corrected when the walls and roof were sprayed with foam insulation. The following IR images show good alignment of the insulation, even coverage and few thermal bypasses.

Fig. 17: Post-construction IR Images
