RESTORATION GUIDE

EXTERIOR WALLS

Restore Your Building with Confidence

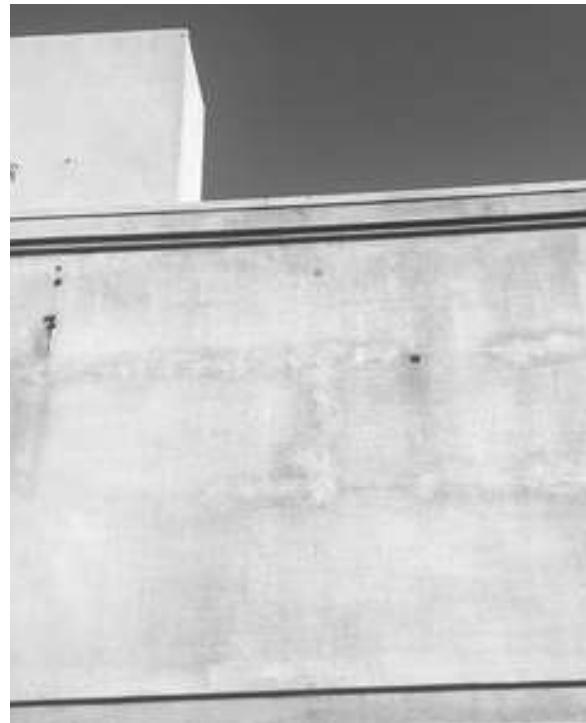
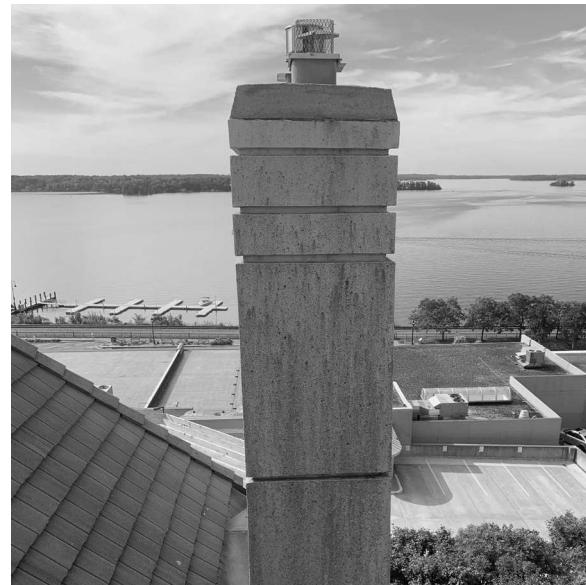
Over the life of a building, dirt will accumulate on the exterior building envelope. Lack of ongoing maintenance and cleaning can lead to stains, microbacteria growth, efflorescence, and other causes of unsightly facades.

Buildings in warm and humid climates can accumulate moisture and dirt on the surface, creating the perfect environment for growth of mold and mildew. This organic growth can appear on many surfaces, including stucco, wood siding, concrete, and EIFS, but can be easily addressed.

Efflorescence is a crystalline salt deposit that may develop on masonry, EIFS, and coatings applied over stucco, precast and other cementitious substrates. The chemical makeup of these deposits can also result in the fading of acrylic paints and coatings.

- Damp and/or humid climates create the environment for mold and mildew growth.
- Elevations do not receive enough direct sunlight to evaporate surface moisture.
- The surface was exposed to moisture during the curing process preventing it from drying out properly.
- Application did not follow industry guidelines, manufacturer mixing instructions, and/or climate-specific conditions.

Review the surface in question to determine the source of the issue and appropriate repair methods. For general cleaning, reference the DS498: DryvitCARE EIFS Repair Guide³. For microbacteria growth, proceed to **Method A**. And for light efflorescence, utilize **Method B**.

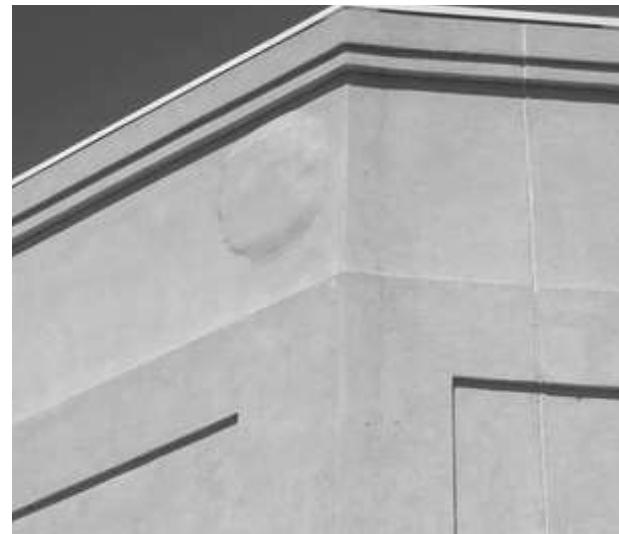
Blisters in a textured finish or wall coating typically appear as bulges proud of the finish surface. It is not unusual to see bubbles form during some environmental conditions and later disappear as a weather cycle develops.

- Finish was applied over an improperly prepared or moisture-laden substrate.

Identify the area(s) in need of repair and perform adhesion testing to verify the integrity of the substrate. Depending on how widespread the issue is, determine if a small patch repair is acceptable or if a larger portion of the textured finish or coating should be replaced.

1. Using a sharp blade, cut around the perimeter of the blister and remove all loose finish material from the affected area. For larger areas, you can also use a brush or scraper to remove loose material to the nearest architectural break point or expansion joint.
2. Examine the surface to ensure that it is dry, clean and free from any contaminants that may inhibit adhesion. For full substrate cleaning instructions, see DS498: DryvitCARE EIFS Repair guide³.
3. Reapply the surface lamina, including base coat, if needed, and finish, according to the manufacturer's installation instructions.

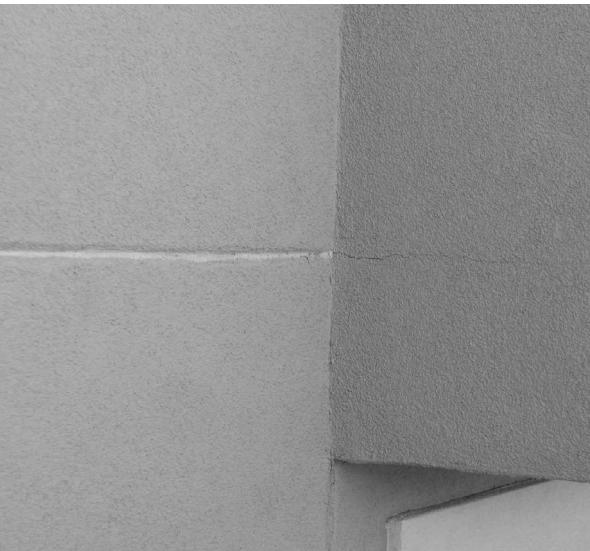
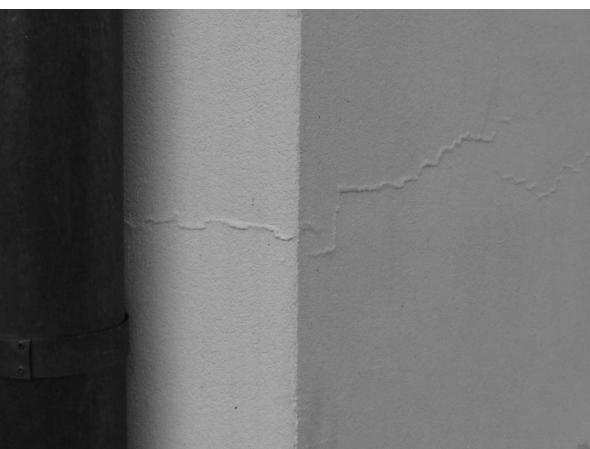
Stress cracks - hairline or greater - in a coating or cladding can present as visible, often nonlinear separation within the façade material. These surface conditions can be caused either by application failure or structural issues. If you suspect structural issues, often diagnosed by cracks larger than 1/8 in. (3 mm) in width, contact a structural engineer for guidance on next steps.

Hairline cracks from normal building movement can be problematic and should be handled in a timely fashion to minimize potential moisture issues within the assembly.

- Lack of sufficient control or expansion joints.
- Cementitious base coat was applied thicker than specified.
- Insulation foam boards were improperly installed.

1. Clean the area so there is no dust or debris.
2. Use a flexible, compatible sealant, such as Tremco's Dymonic 100⁴, to infill the crack. Allow to cure fully.
3. Install a coating, such as Dryvit's Demandit Advantage⁵, over top of the crack, per manufacturer's installation instructions to match the color of the surrounding coating.

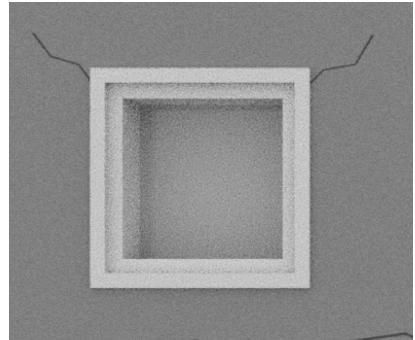
1. Corner of penetrations

- a. EPS boards must be “picture framed” around corners of windows, doors, and other penetrations. They should be reinforced with mesh and base coat per manufacturer’s installation instructions and industry guidelines to avoid stress cracks. Foam joints should not be located within 6 in. (15 cm) of a corner.

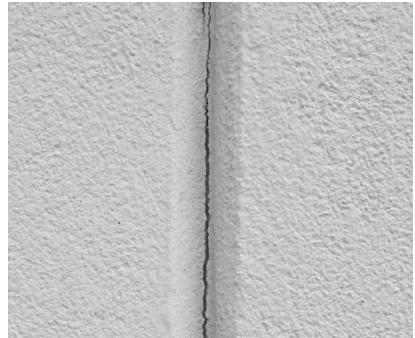
2. Vertical crack in v-groove

- a. If joints between the EPS insulation boards line up with joints in the sheathing, it creates an overall weak point in the system.
- b. A cut in the mesh of the v-groove during installation.
- c. Fracture in EPS insulation board if it is applied below the $\frac{3}{4}$ in. (19 mm) industry standard thickness.

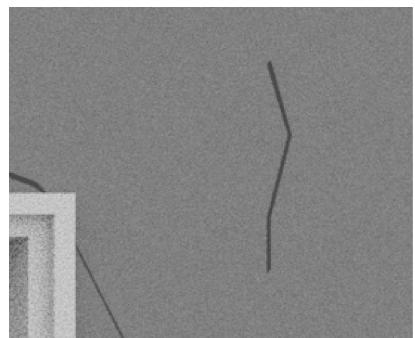
3. Seemingly random vertical crack in the middle of the wall

- a. If gaps in the EPS insulation boards greater than $\frac{1}{16}$ in. (2 mm) are not filled with insulation material, base coat will fill into those areas and can cause cracking from the materials’ different movement capabilities.
- b. Unanticipated building movement.

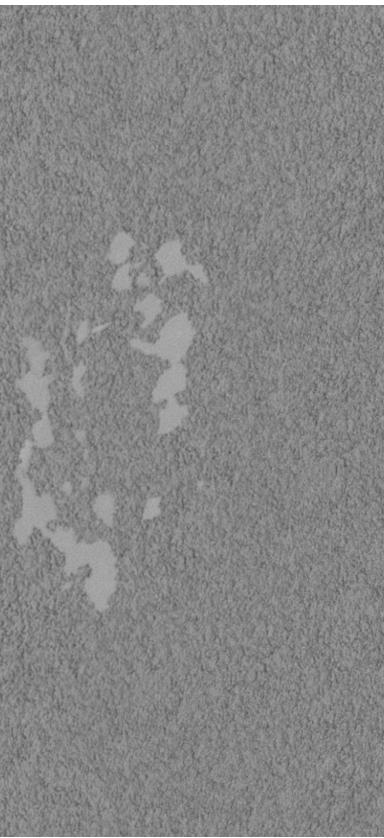
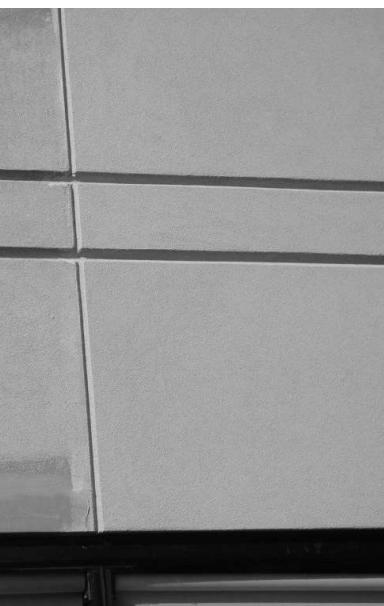
Degradation of acrylic finishes on the exterior of a building can be identified by the thinning of the finish coat, which exposes the aggregate and/or underlying basecoat.

- Extended exposure to UV or extreme weather.
- Building maintenance was neglected.

1. Remove loose material mechanically via a brush or scraper to reveal a sound substrate.
2. Examine the surface to ensure that it is dry, clean and free from any contaminants that may inhibit adhesion. For full substrate cleaning instructions, see DS498: DryvitCARE EIFS Repair Guide³.
3. Apply a non-cementitious acrylic base coat, such as Dryvit's NCB⁸, between architectural break points, according to manufacturer's installation instructions to provide a smooth, level surface.
4. Apply a new textured finish coat to match the existing finish per manufacturer's installation instructions. To restore a specialty finish, such as metal, brick, stone, or woodgrain, contact your local Tremco CPG representative.

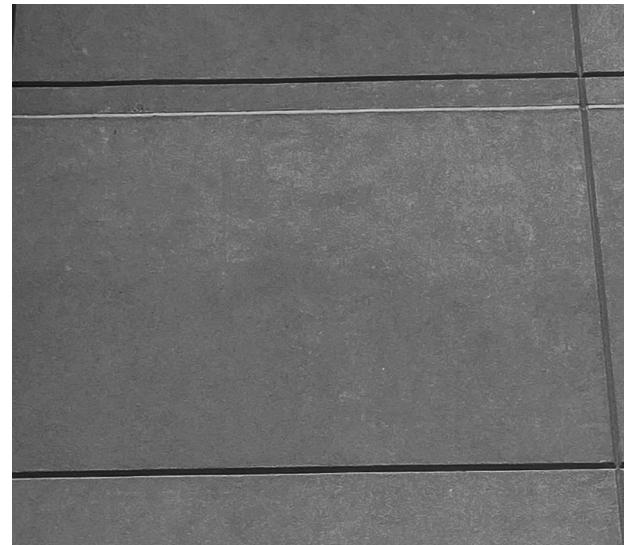
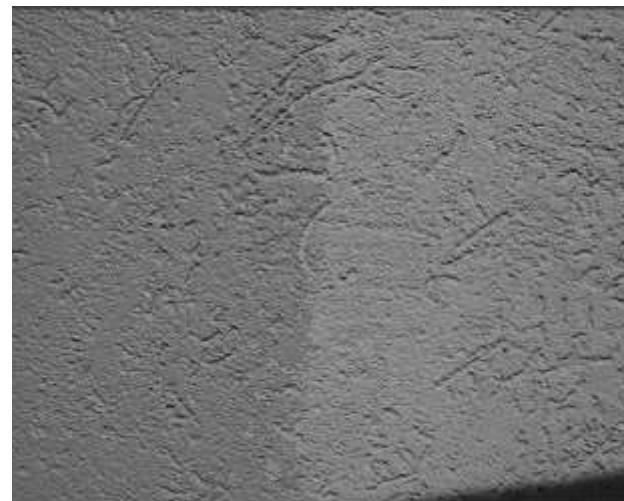
Pigments in acrylic coatings and textured finishes can fade over time from extended UV exposure. Bold and darker colors, such as reds and blues, tend to show more visible fading. UV fading can occur on numerous surfaces, including stucco, wood siding, concrete, and EIFS. Proper product selection and application is also critical. Choosing a high-quality colorant, such as Dryvit's Stratatone⁹, and a high-quality coating will provide better UV protection.

- The surface has not received proper maintenance.
- Low quality paints have been used.
- The coating was applied too thin and not in accordance with the manufacturer's recommended mil-thickness.

1. Clean the surface for recoating, and remove any loose and bond-inhibiting materials, such as dirt, oil, or tough stains. For full substrate cleaning instructions, see DS498 DryvitCARE EIFS Repair Guide³. Allow the substrate to dry.
2. Reapply a coating according to the manufacturer's installation instructions. Consult with a Tremco CPG representative for recommendations on proper product selection to achieve desired performance and aesthetics. For smaller areas, use a high-quality acrylic coating, such as Dryvit's Demandit Advantage⁵. For whole building recoats, a hydrophobic coating, such as Dryvit's HDP⁶, may be better suited.

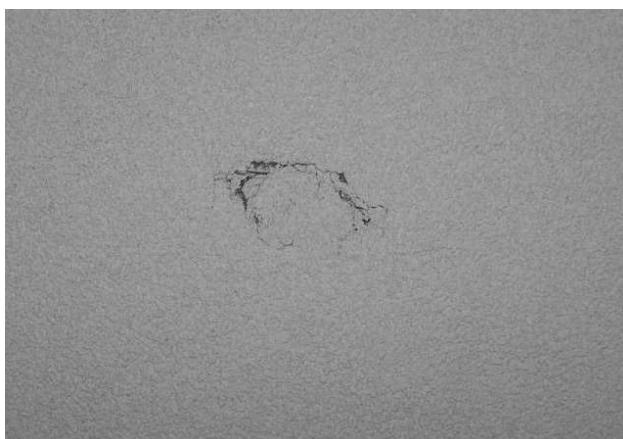
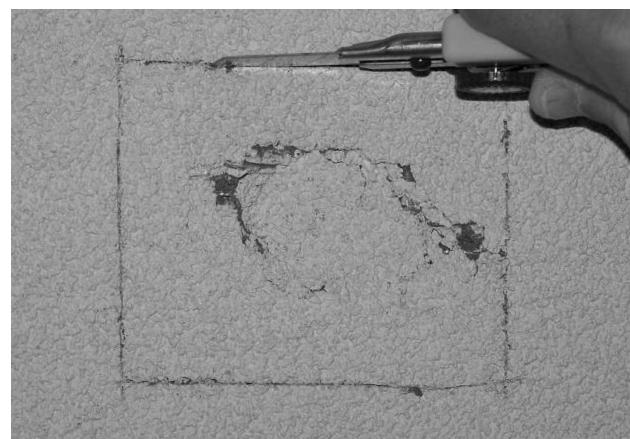
Unintentional impact to a building is an unfortunate occurrence that can cause varying degrees of damage. Areas of the facade where pedestrians can come into close contact will require the application of heavy impact meshes for more robust protection. Lack of the proper heavier meshes will translate to impact damage when subjected to abuse from landscaping activities, vandalism, severe hail, etc.

- Lack of the proper reinforcing mesh in the lamina.

1. Neatly cut out an area slightly larger than the damaged area down to the substrate with a sharp utility knife.
2. Replace the EPS foam with a new piece cut to the same size. The fit should be tight without any gaps between the new and existing EPS. If needed, sliver in pieces to fill any remaining gaps.
3. A new lamina can now be applied with the appropriate weight mesh, referencing the manufacturer's application instructions. Apply new noncementitious basecoat, such as Dryvit's NCB⁸, and mesh within the designated architectural break points. Apply the new finish coat with texture and color to match the existing cladding following manufacturer's installation instructions.
